Manhole Inspection Summary

Manhole # S11WW_007MH

Insp Date: **7/10/09 11:02 AM**

Location Address: **3402 HILTON RD**

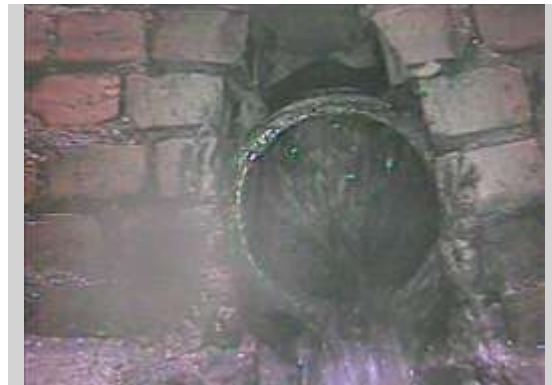
Drop In @ 3 O'Clock

Drop: **Outside Direct**
Angled: Reading: (ft.)
Inv Depth: **12.62** (ft.)
Drop Condition: **Open**

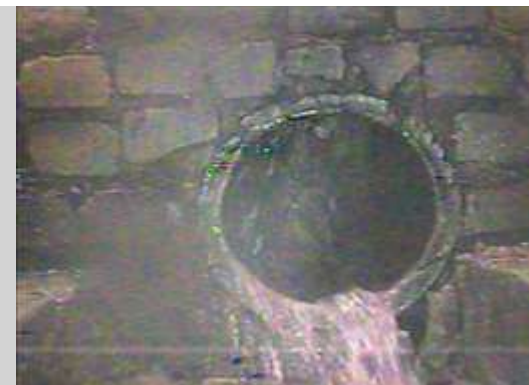
Drop In @ 6 O'Clock

POSSIBLE ROOT INFILTRATION

Infiltration: **None** Pipe Seal Cond: **Broken**
